Some Things to be Learned from the “Other” Compressed Gas Fuel System

Clean Vehicle Education Foundation

ABSTRACT

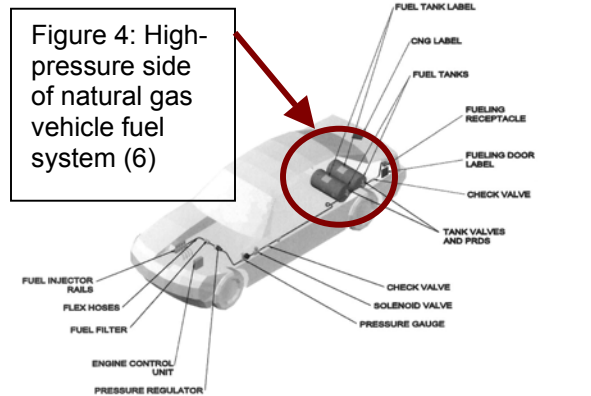
This paper concentrates on the high-pressure cylinder and related items, particularly the cylinder and the pressure relief device normally used to protect against cylinder rupture in a fire.

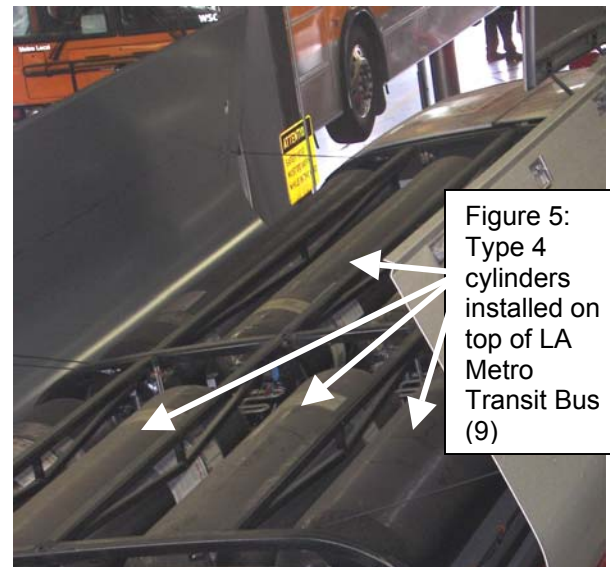
Type 1 steel cylinders are the least expensive and the heaviest. They are generally used on CNG vehicles in the developing world. Type 3 and 4 cylinders, wrapped with fiberglass and/or carbon filament, are the lightest and most expensive cylinders. Because of their relatively light weight (1/4 – 1/2 the weight of an equivalent steel type 1 cylinder), they are generally used in the US on OEM natural gas vehicles, such as transit buses and are the type of cylinders normally considered for vehicles operating on compressed hydrogen.

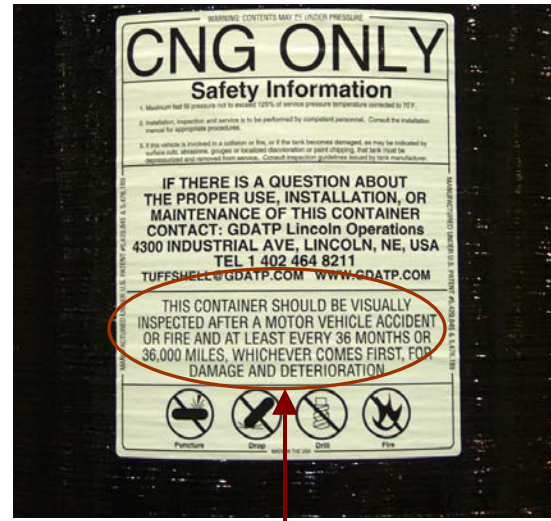
Figure 6: CNG cylinder label with inspection requirements (11)

miles or when they have been involved in collisions, accidents, fires or other damage (ANSI/NGV2 §§4.1.4 & 4.1.5) Specific inspection procedures are provided in the Compressed Gas Association’s pamphlet C-6.4, supplemented by the cylinder manufacturer’s own inspection instructions. There are a number of ways of providing the “qualified” inspectors required by CGA C-6.4, the best known being the CSA inspector qualification test (12), which now provides over 500 certified inspectors nationwide.

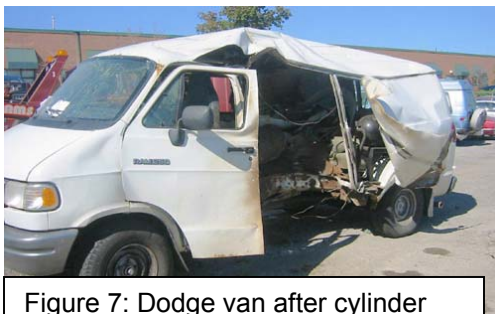
CYLINDERS/FUEL SYSTEMS NEED INSPECTION – In September 2003, in Scarborough, Ontario (a suburb of Toronto) a cylinder ruptured during fueling of a Dodge Ram van which had been converted to CNG in 1994. “Apparently the cylinder failed during fueling at substantially under its rated 3000 psi (200 Bar). The driver said he had smelled gas for a long time but hadn’t gotten around to checking the source. It was reported that there was massive external corrosion on the tank and there was no evidence of it having been inspected.” (16)

Figure 7: Dodge van after cylinder rupture (17)

As discussed above, the natural gas vehicle industry advises cylinder users to routinely have a detailed visual inspection at least every 36 months and FMVSS 304 requires the cylinder label to state that “This container should be visually inspected after a motor vehicle accident or fire and at least every 36 months or 36,000 miles, whichever comes first, for damage or deterioration.” On the Dodge van, the Canadian cylinder registration required an inspection every three years. (18)

A detailed visual inspection, conducted per the Compressed Gas Association pamphlet C-6.4 (Methods for External Visual Inspection of Natural Gas Vehicle Fuel Containers and Their Installations) (19) referenced in the industry container standard, ANSI/CSA NGV2, includes inspection of much of the CNG fuel system, not just the fuel container. Therefore these inspections find gas leaks, PRD or fuel line damage, and many other potential problems before they lead to an incident. Periodic CNG fuel system inspections are no different from brake, headlight or tire inspections in their ability to help ensure safe vehicle operation.

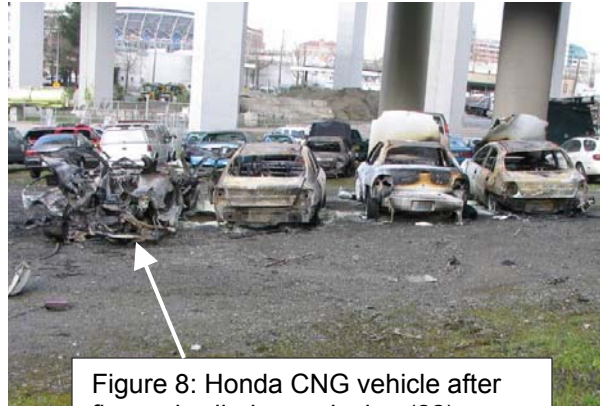
On March 26, 2007, an arsonist torched 12 vehicles in a Seattle, WA city government holding lot. All the vehicles were damaged or destroyed including a CNG Honda GX, whose fuel tank exploded in the fire. The tank was apparently compromised by fire moving from the back seat area onto the center of the cylinder, which was protected by a PRD at one end.

Figure 8: Honda CNG vehicle after fire and cylinder explosion (22)

Lesson for compressed hydrogen vehicles: Although PRDs normally successfully protect CNG cylinders from explosion in vehicle fires, there are cases where present designs may not protect from localized fires. This could become a more serious concern if high volumes of compressed hydrogen vehicles on the highways using Types 2, 3, and 4 cylinders, are not protected by more advanced fire-sensing systems.
